Wooden Beams from Herod's Temple Mount: Do They Still Exist?

By [Peretz Reuven](#)

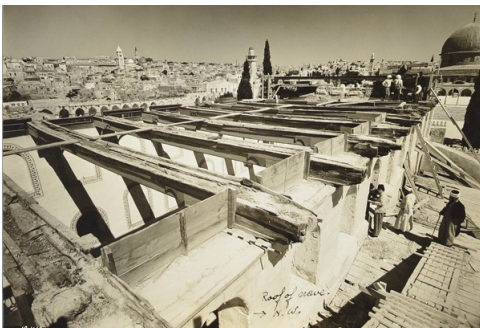
RAISE THE ROOFBEAMS. After being severely damaged by earthquakes in 1927 and 1937, Al-Aqsa was largely dismantled and the ancient wooden beams were removed from the mosque. Examination of the Cedar of Lebanon and cypress beams by R.W. Hamilton, the director of the British Mandatory Department of Antiquities, revealed that many showed signs of secondary use, and must have been used in an earlier structure as well.

It is clear from Hamilton's careful report of the reconstruction following the earthquakes of 1927 and 1937 that most of the mosque's Cedar of Lebanon and cypress wood was in secondary use after having been used in an earlier construction (or constructions). The beams often display depressions and protrusions intended to hold them in place from their earlier use.

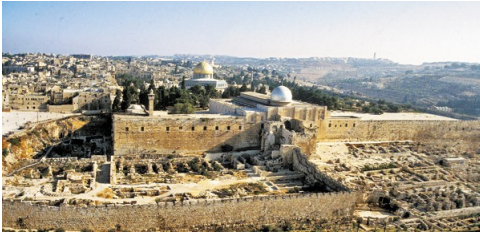
BUILT ON SACRED GROUND. Considered the third holiest Muslim site, the iconic gray-domed Al-Aqsa Mosque sits on the southern end of Jerusalem's Temple Mount. When Herod the Great expanded the sloping southern end of the Temple Mount with massive buttress walls, vaults and dirt fill, he constructed the Royal Stoa where Al-Aqsa stands today.

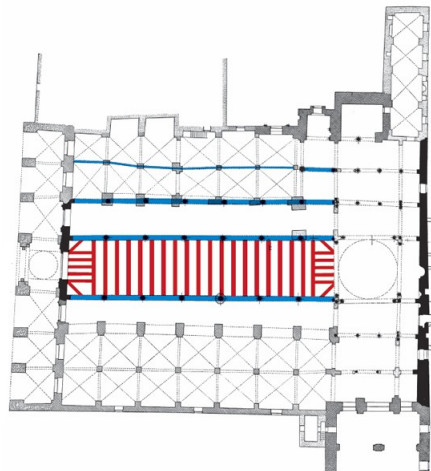
Enormous wooden beams throughout the mosque serve a variety of structural and aesthetic functions. The tie beams (red) on the nave ceiling that support the roof were covered with carved or painted panels and were adorned with elegantly carved cypress boards on their ends. Bond timbers (blue) were built into the arcade walls that separate the aisles and the nave. The timbers were placed in tiers parallel to the ground above the column capitals, under each row of upper windows, and beneath the ceiling tie beams. Additional smaller beams (not indicated here) removed from other sections of the mosque also predate the construction of Al-Aqsa and show signs of secondary and tertiary use.

The construction of the mosque included enormous wooden beams—mostly Cedars of Lebanon and cypress—in the ceiling to support the roof. Similar beams were used in the dome over the southern part of the nave. Twenty great tie beams (principal beams) span the width of the central nave. On each end of the tie beams were carved cypress boards. These great tie beams are more than 42 feet long! The principal rafters of the roof rested in slots cut in the upper surface of these tie beams above the two long walls.

At certain levels, beams were built into the length of the walls as bond timbers (horizontal tiered beams that strengthen walls longitudinally). In the nave, the highest of the bond timbers were placed at the top of the walls and served as wall plates to carry the principal tie beams of the nave roof. The next levels of bond timbers rest under each row of upper windows. The lowest bond timbers are tie beams above the capitals of the columns. Throughout the length of the arcades the main beams are scarfed (or joined) together above the capitals. Each arcade is branched by a series of wooden tie beams

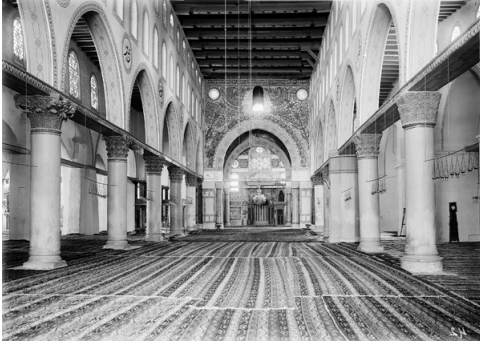
HIDDEN BEAUTY. Visitors would not have seen Al-Aqsa's ancient wooden beams exposed before they were dismantled in the 1930s and 1940s. As seen in the archive photo above, dark painted boards, affixed with nails and brackets, covered beams on the nave's ceiling, and the bond timbers over the columns were elegantly painted or covered by plaster and whitewash.

laid end-to-end on the capitals. When stripped of some modern boards that covered them, the tie beams in the central nave, and in some cases in the side aisles, were covered with paintings that can be dated from the 11th to 13th centuries.

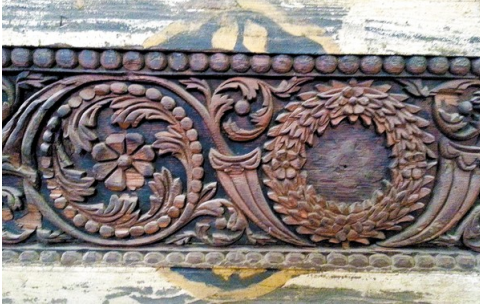
ROSETTES AS A ROSETTA STONE. In the ceiling of Al-Aqsa's nave, the Byzantine-era floral carvings help decipher the layered history of this beam. The wood was carbon-dated to sometime between the first century B.C.E. and the third century C.E. The decorations match the style of Byzantine church beams from the sixth century, suggesting that the beam's placement in the mosque was at least a tertiary use.

Carvings of rosettes on the soffit (underside) of a principal beam supporting the nave bear a striking resemblance to rosettes in the sixth-century Church of the Nativity in Bethlehem, indicating that the Al-Aqsa beam probably came from a Byzantine church and its earlier use should be dated to the same period as the church.

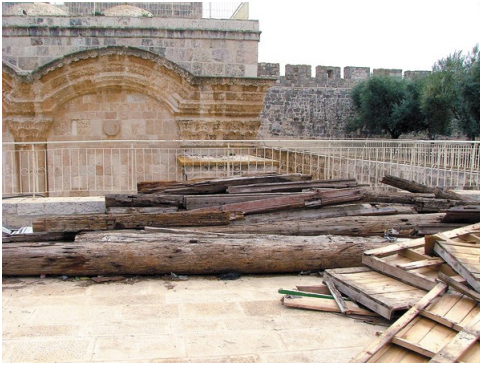
EXPOSED TO THE ELEMENTS. When Al-Aqsa Mosque was dismantled decades ago for restoration, the old beams were left in various locations around the Temple Mount. After being moved to storehouses or piled near the south wall of the Temple Mount, later displacements left the ancient woodpile stashed near the Golden Gate in an attempt to keep the beams out of view.

As a result of concerns expressed by the Public Committee Against the Destruction of Antiquities on the Temple Mount, a nonpartisan committee that included leading Israeli archaeologists, historians and legal experts, a pile of these timbers was recently removed to the area behind the Golden Gate, an area of the Temple Mount less frequented by visitors, where timbers are less likely to be carried away. But they were left unprotected. Exposed to the elements, they will soon begin to disintegrate.

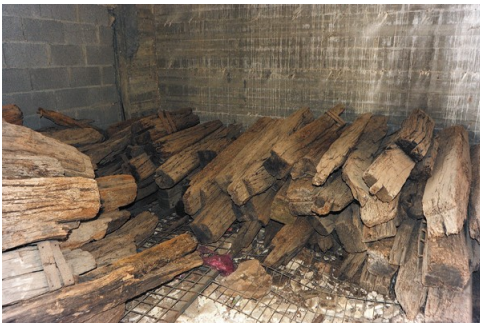
PILED HISTORY. This group of timbers was removed from the roof and dome of Al-Aqsa Mosque during restorations in the early 1960s. It was reportedly purchased by a West Bank junk dealer and then resold to a settlement, where it is now stored. The ends of 140 of the beams were sawed off for dendrochronological study, and others were analyzed with carbon-14 testing to reveal an expansive date range: The youngest beams were cut after the initial construction of Al-Aqsa Mosque, while others date to the First Temple period, from the ninth to seventh centuries B.C.E.

In the early 1960s, the dome of Al-Aqsa was restored. At that time a large group of unused beams was removed from the roof of the mosque. Many of these beams were reportedly sold to a man named Baziyan, the largest junk dealer in the West Bank. Some of these beams were subsequently purchased and stored in a West Bank settlement, where they were examined by the author and the editor of this magazine. The current owners believe that some of this wood may have come from Herod's Temple.
